A Review of Australian and New Zealand Investigations on Aeronautical Fatigue During the Period April 2005 to March 2007

Air Vehicles DivisionDefence Science and Technology Organisation

DSTO-TN-0747

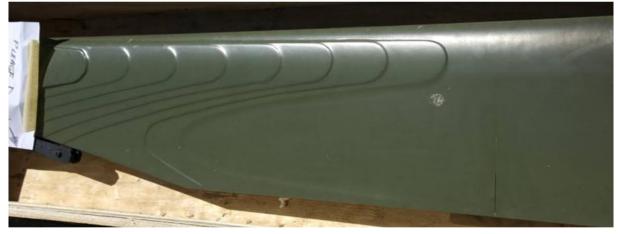
Figure 34: Photograph of the crack (lower right, vertical on page) in the MRB showing its location in relation to the blade root

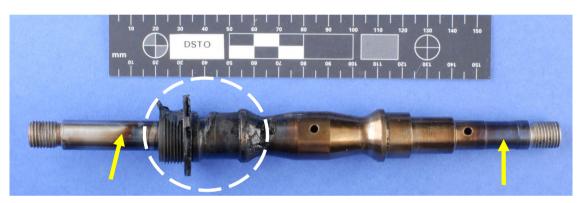
Figure 44: Photograph of severely heat damaged shaft from the Turbo Compressor

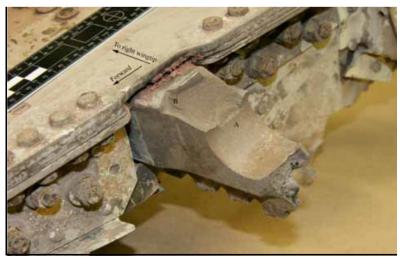
Figure 55: Broken lug on the inboard end of the right wing
